MASTER PLAN

YMCA CAMP IMMOKALEE

KEYSTONE HEIGHTS, FLORIDA

FEBRUARY 12, 2020

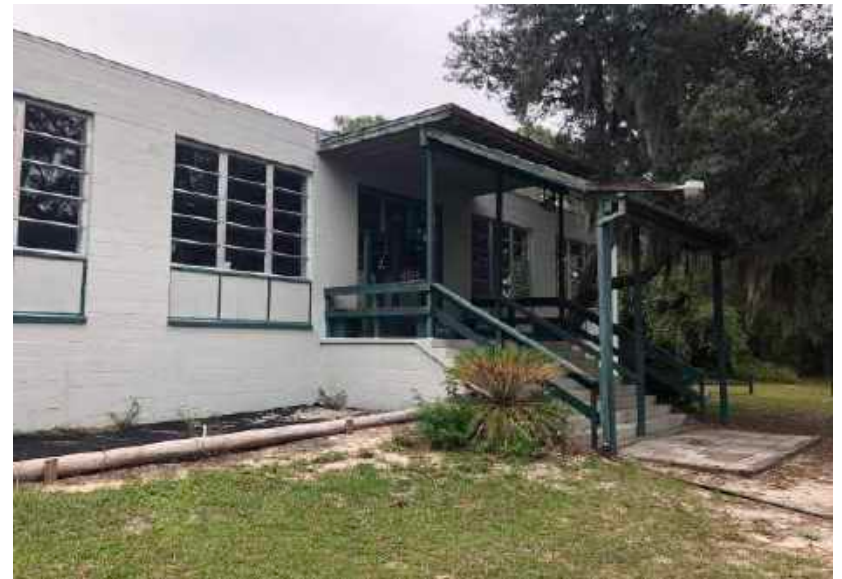
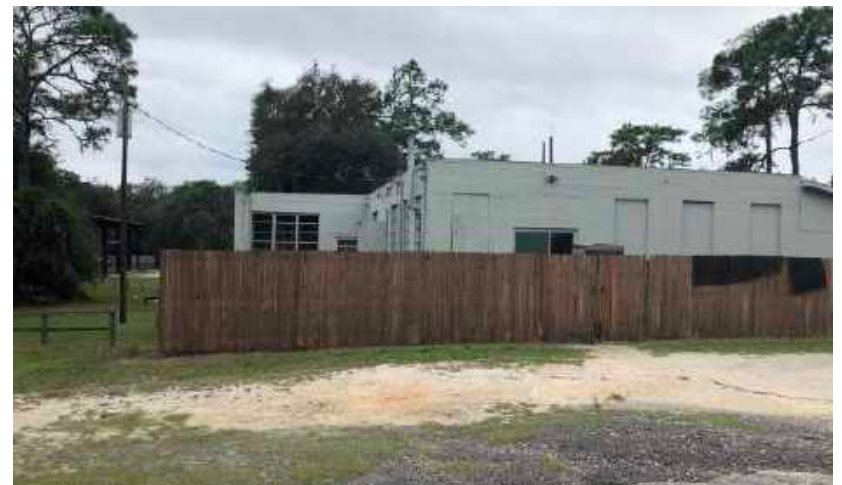
2. Dining Hall

b. Interior: The building interior currently functions as the dining hall, complete with commercial kitchen. The dining room seats between 180 and 200 guests. There are restrooms with an accessible toilet stall. The interior wall finish is a combination of painted concrete block, painted wood sheets and painted gypsum board. The roof structure is steel bar joists and the ceiling is stained tongue and groove wood. It is unknown if the walls or roof have insulation. The building is climate controlled with a central HVAC system, with exposed duct runs into the dining room. Suspended ceiling fans and light fixtures hang in the dining room.

c. Accessibility: Although there are components of the building that comply with accessibility, the building is not accessible. There is a ramp leading to the building, but there is no accessible parking (although there is a grassed area noted to be used for accessible parking) and the approach to the ramp is not accessible. The ramp and railings are not ADA compliant. The restrooms do contain an accessible toilet stall with lavatory.

d. Staff Comments: The building serves its purpose as a dining hall. The roof is not in good shape and should be replaced.

- A new dining hall in a more central location is recommended for construction.
- Retain the current dining hall in its current location to function as a multi-purpose gathering space/meeting room.

- Provide accessibility through an accessible approach and compliant ramp to the building.
- Evaluate the roof, likely will be due for replacement. If undergoing roof replacement, consider modifying the roof to a pitched roof.

- On the interior, retain the kitchen to serve as a secondary kitchen and as the infrastructure for a future cooking program.
- Evaluate the HVAC system to determine replacement needs. Replace ductwork with concealed ductwork, or with exposed ductwork that has been designed to be exposed.

- Provide a new finish material on the building exterior to blend with the existing campus buildings, providing replacement exterior railings, and possible window and door replacement.
- Insulation will need to be added to the attic and walls if found lacking.

f. Master Plan Phasing: The new dining hall is recommended for construction in the Master Plan Phase 7. Upon completion of the new dining hall, renovation and repurposing of the existing dining hall is planned for Phase 9.

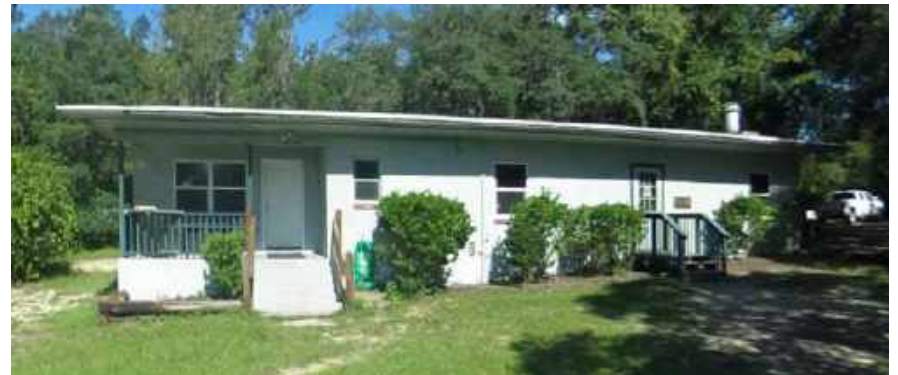
6. Welcome Center

a. Exterior: The single story building exterior envelope is slab on fill construction, with painted concrete block walls and a low slope roof, perhaps asphalt paper. The windows are single hung, exterior soffit is vented and is some type of fiber cement product or smooth plywood. The building is climate controlled with window air conditioning units. The building has 4 exterior doors, 2 stoops with steps and handrails, and one porch with steps and handrails. It has a fireplace and chimney at one end.

Staff suggests roof replacement and central air conditioning and would like to see a large welcoming front porch with rocking chairs.

- Retain the building in its current location to function as the Welcome Center for Camp Immokalee.
- Improve the entry drive and parking spaces and provide accessible parking.
- Provide an accessible route to the building and a ramp as required to reach the building floor elevation.
- At the current apartment entry, retain existing concrete front porch but remove concrete steps and wood railing.
- At the current office/welcome entry, remove wood stoop, steps and railings. Provide new wood or composite porch with new railings along full length of building.

- Retain windows and exterior doors. Paint doors.
 - Remove existing roof and soffit. Consider removing existing roof framing and replace with sloped wood trusses to accommodate a sloped roof.

- Remove existing window air conditioning units and provide central heat and air, utilizing the newly created attic area for ductwork runs.
 - Provide insulation in the attic.

- Renovate building interior to meet the program parameters as described above in Staff Comments.
 - Clean and repair the fireplace to working condition.

- f. Master Plan Phasing: The renovations to the building and new site improvements are recommended to be accomplished as part of Master Plan Phase 5.

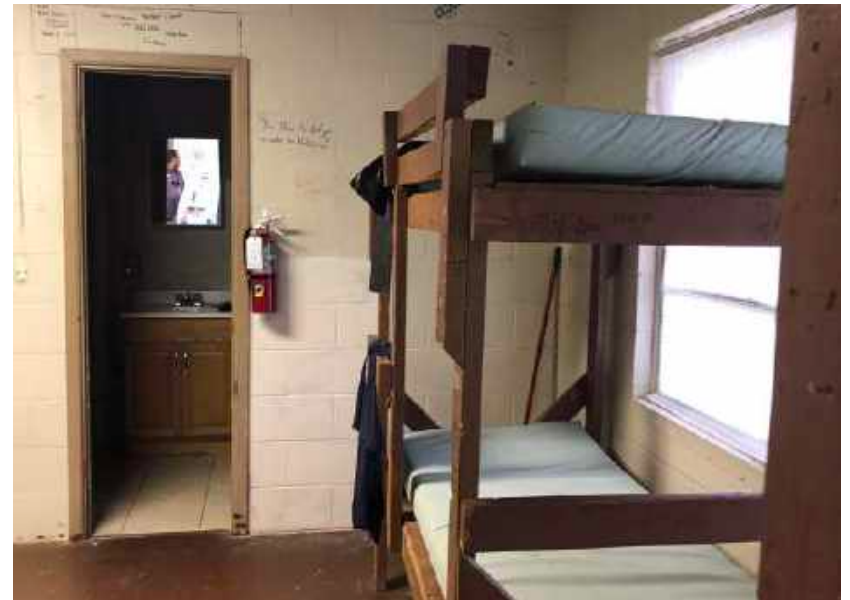
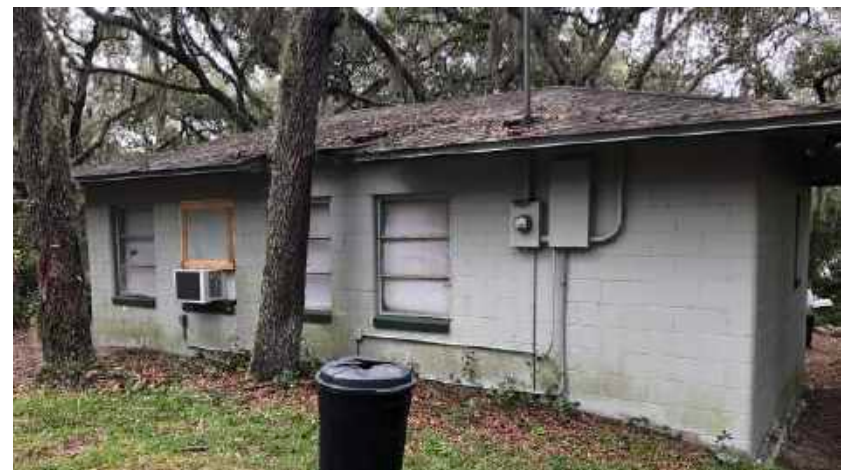
26. Camper's Kybo (Bathhouse)

a. Exterior: The bathhouse exterior construction is concrete masonry unit walls and foundation with concrete floor slab on grade. The roof structure is wood trusses with a shingle roof.

- Remove/demolish this structure, as it is in poor repair and will be replaced by a new accessible bathhouse.

f. Master Plan Phasing: It is recommended that this structure be removed as part of Master Plan Phase 7.
